CHEMICAL CORROSION AND FRACTURE OF A "HOT" PIPELINE OF AN AMMONIA-SYNTHESIS COLUMN

We investigate the character of fracture of welded joints of a gas pipeline made of 18Kh3MV steel after passing the ammonia synthesis column. Hydrogen corrosion of welded joints and nitration that proceed under the action of high temperatures (up to 350°C) and pressures (up to 32 MPa) in mixtures of nitrogen with hydrogen and ammonia are important for fracture.

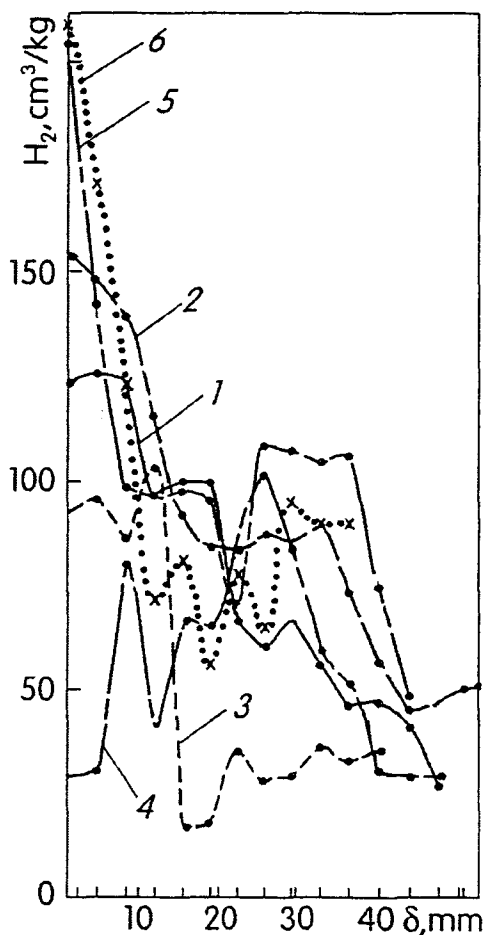
a microhardness of the matrix of 3.4 GPa means that this layer (ferrite saturated with nitrogen) is rather brittle and easily cracked. Decarbonization of steel became possible due to a decrease in the amount of alloying elements, chromium and molybdenum, in the matrix. These elements form carbides in the course of time, which is confirmed by the analysis of carbides. In the original state, molybdenum in carbides accounts for 20.9% and, after 20 years of service, reaches as high as 43.3%. A certain amount of carbon is also bound in carbides. For this reason, the decarbonized layer is very small. Hydrogen corrosion proceeds according to the mechanism of penetration of atomic hydrogen into a metal, as demonstrated by a decrease in the amount of hydrogen with removal from the internal surface to the external one. For example, for a welded joint and the pipe, it decreases from 210 to 30–90 cm³/kg (see Fig. 1). We observed splashes of the concentration of hydrogen in the defects of welded joints. In pipes and flanges, where defects occur more rarely, the amount of hydrogen smoothly decreases from the internal surface to the external one.

Fig. 1. Distribution of hydrogen in a welded joint across the thickness of the pipe from the internal surface in the flange (1), transition (2), welds (3-5), and pipe of $\varnothing 419 \times 42$ mm (6).
